## Specialized Bicycle Components Canada Inc. recalls Flux and Stix Lights

<b>Starting date:</b>	May 4, 2016
<b>Posting date:</b>	May 4, 2016
<b>Type of communication:</b>	Consumer Product Recall
<b>Subcategory:</b>	Sports/Fitness
<b>Source of recall:</b>	Health Canada
<b>Issue:</b>	Burn Hazard
<b>Audience:</b>	General Public
<b>Identification number:</b>	RA-58056

#### Specialized Flux and Stix headlights and taillights

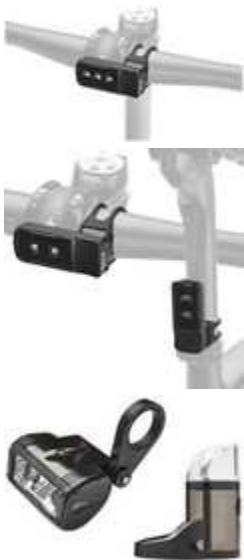
The headlights and taillights can overheat, posing fire and burn hazards.

Outside of Canada, Specialized has received four reports of Flux headlights or taillights overheating and two reports of Stix headlights expanding and bursting. No injuries have been reported.

### **Consumers should immediately stop using the recalled headlights and taillights.**

**Stix lights and Flux Expert taillights:** Consumers should return all Stix lights and Flux Expert Taillights to an Authorized Specialized Retailer for replacement.

**Flux headlights:** Consumers should return all Flux Expert and Elite Headlights to an Authorized Specialized Retailer for a firmware upgrade.
